Report No. FAA-SS-73-10

**SST Technology
Follow-On Program-Phase II**

**DEVELOPMENT AND EVALUATION
OF FUEL TANK SEALANTS**

FINAL REPORT
Task II

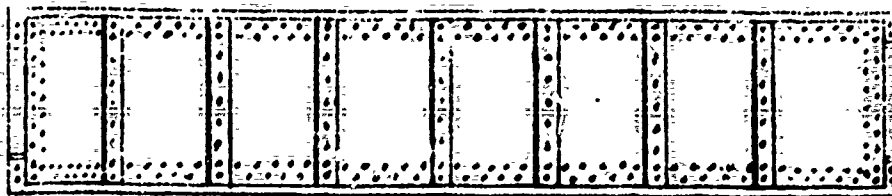
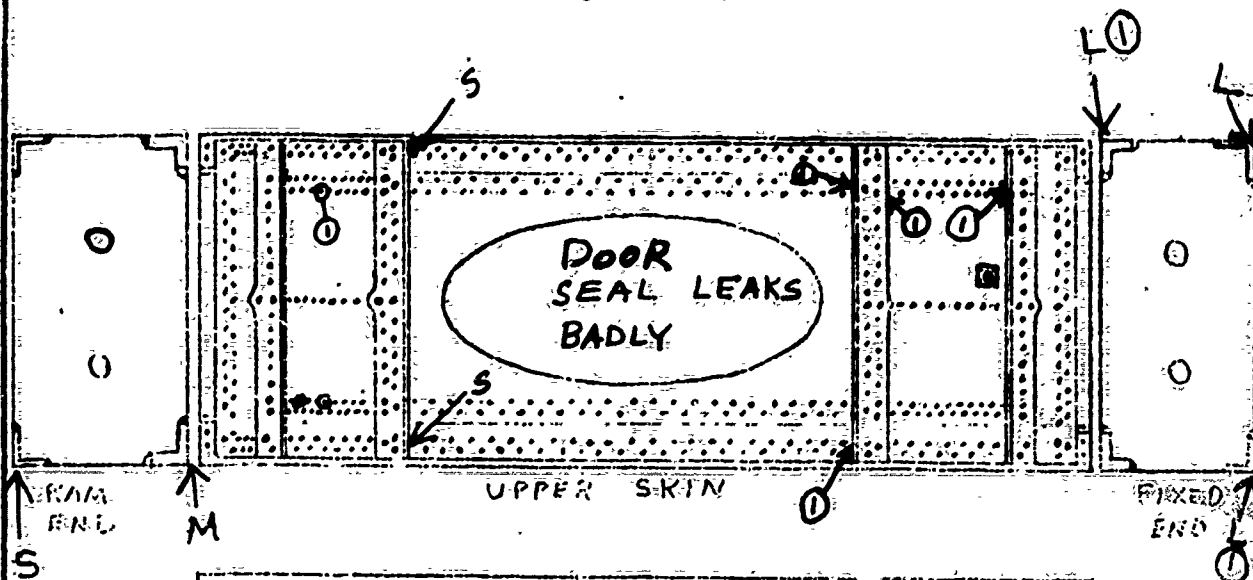
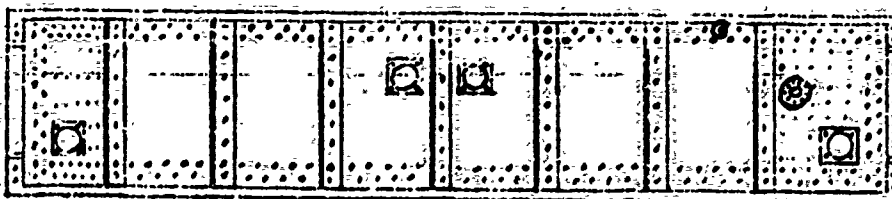
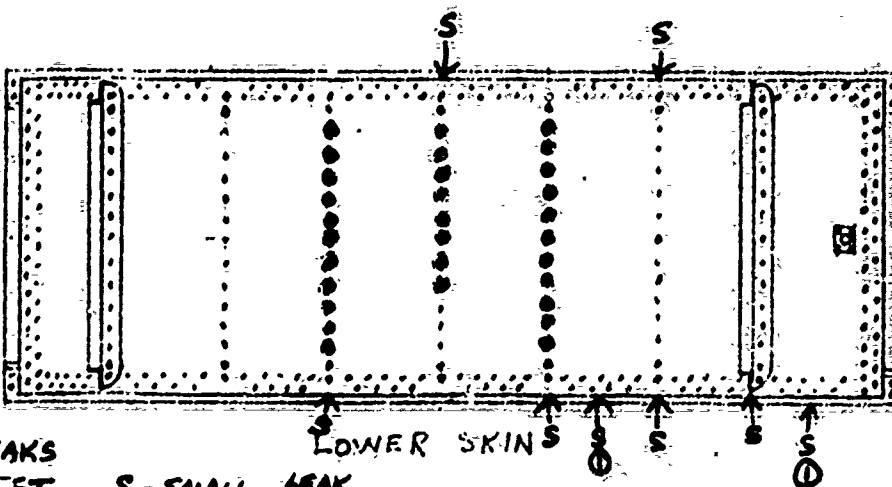
SUMMARY:
9 NEW
LEAKS

CALC	Lu	1-4-72	REVISED	DATE	TANK NO. 3 LEAKAGE TEST NO. 7	
CHECK					AFTER 22 ENVIRONMENTAL	
APP					CONDITIONING CYCLES	
APP					THE BEIND COMPANY AUSTIN, TEXAS 78701	
CONTACT NO.						PAGE B-12

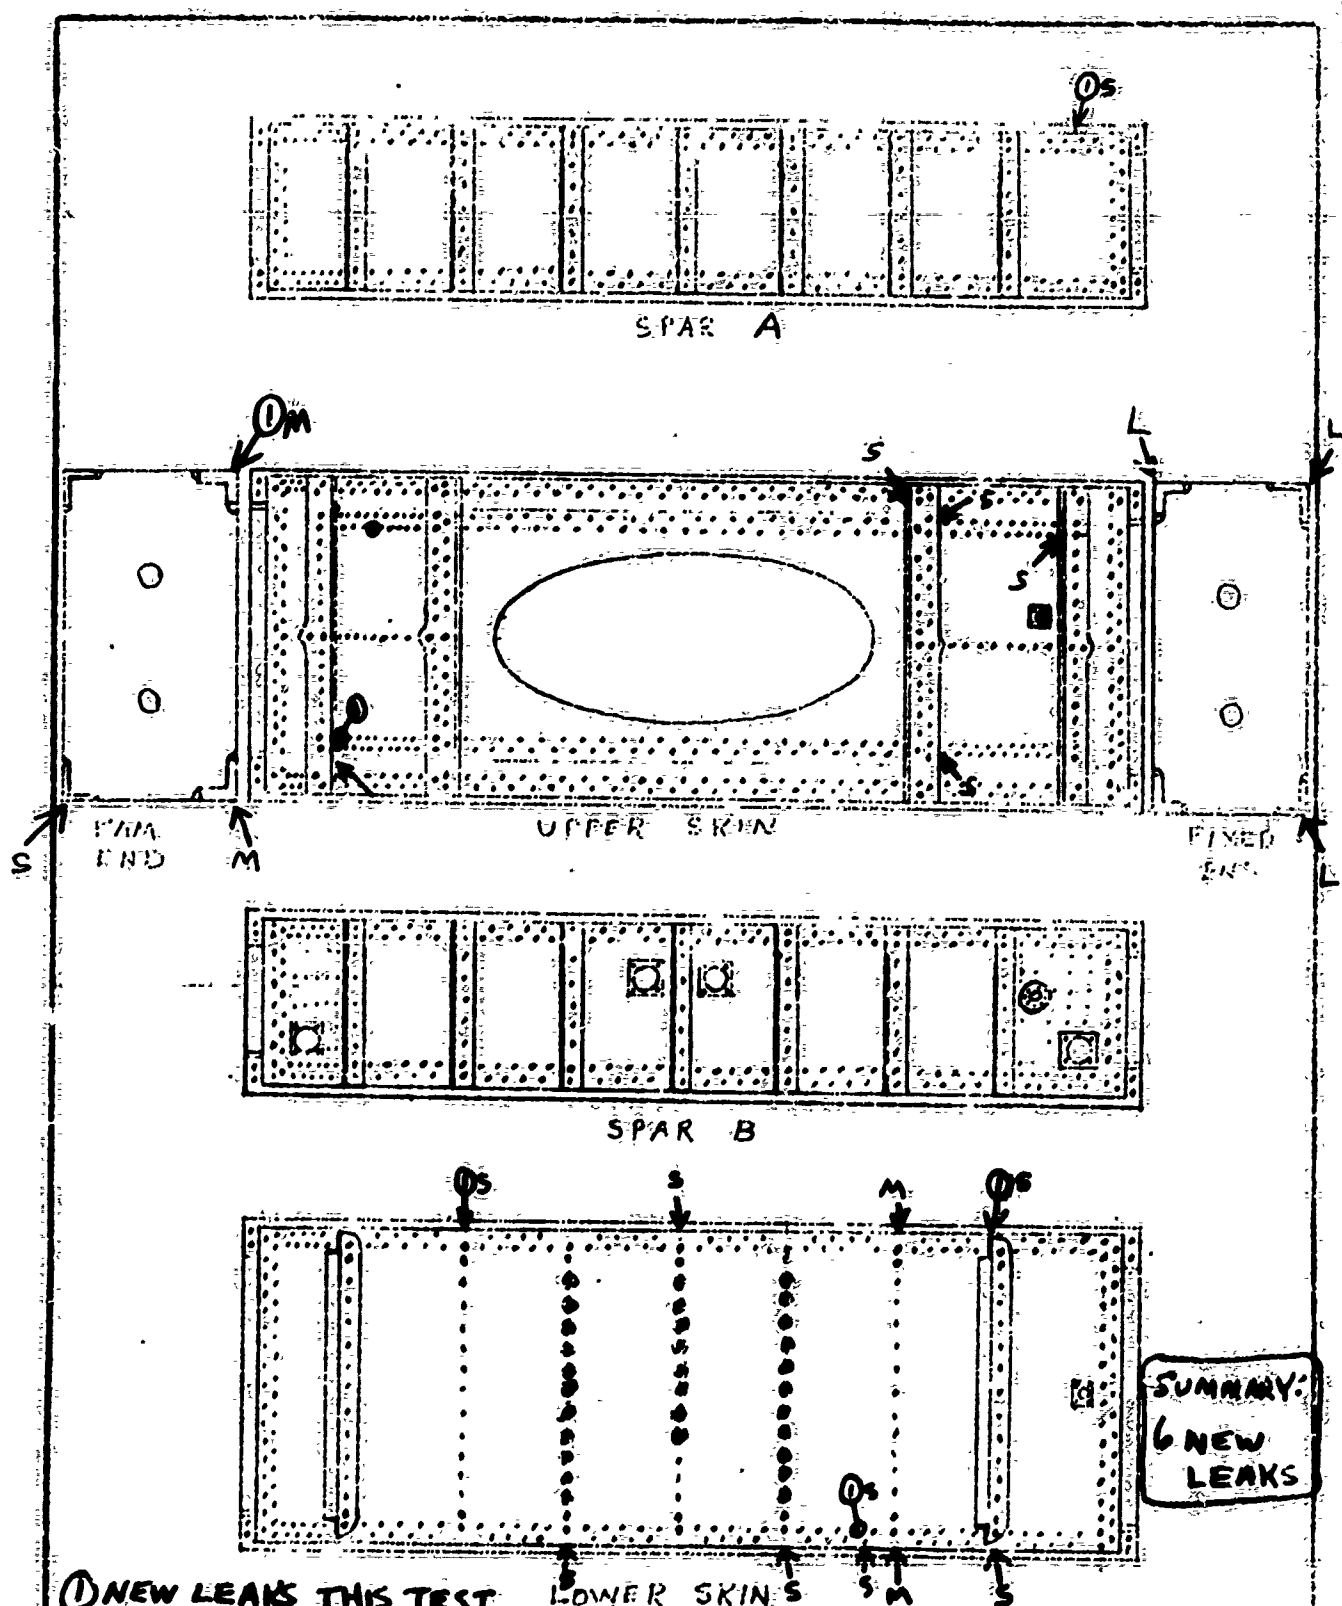
① NEW LEAKS THIS TEST

CALC			NOTED	DATE	TANK NO. 3 LEAKAGE TEST NO. 8
CHECK					AFTER LOAD CYCLING AT 3 TEMPS.
APR					(FOLLOWING 22 CYCLES OF ENV. COND.)
APR					
CONTRACT NO.					THE BOEING CO. PANY BOEING COMPANY 10000 BOEING BLVD. ST. LOUIS, MO. 63114
REV. C					186
D3-8297					Page 104.9

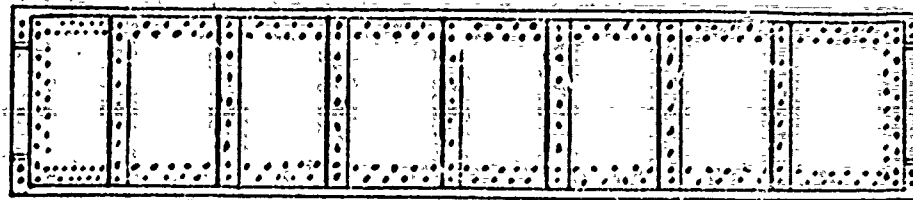
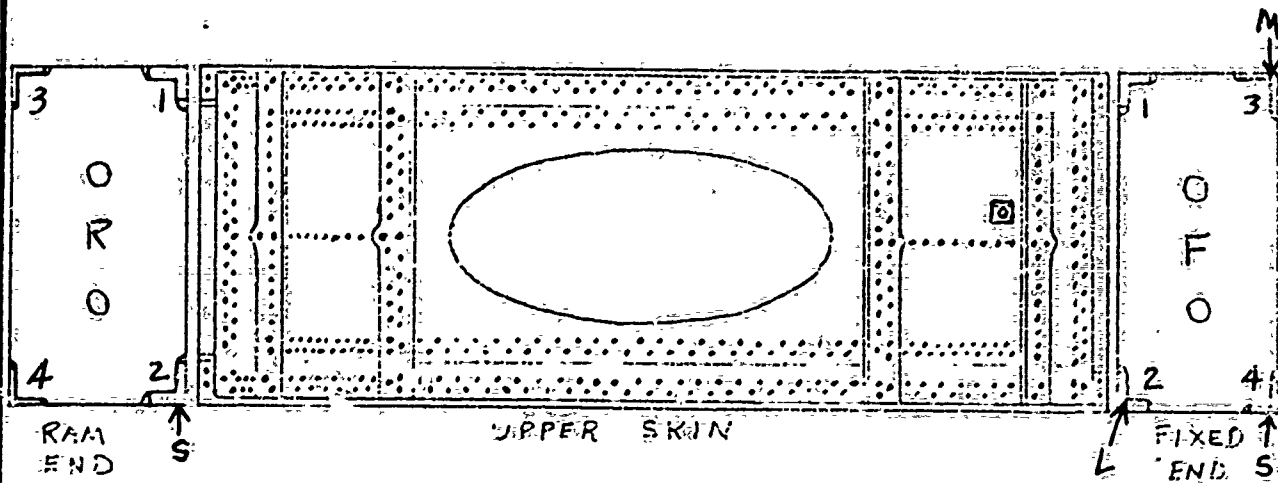
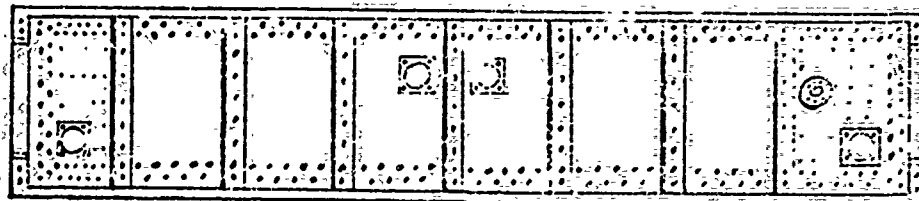
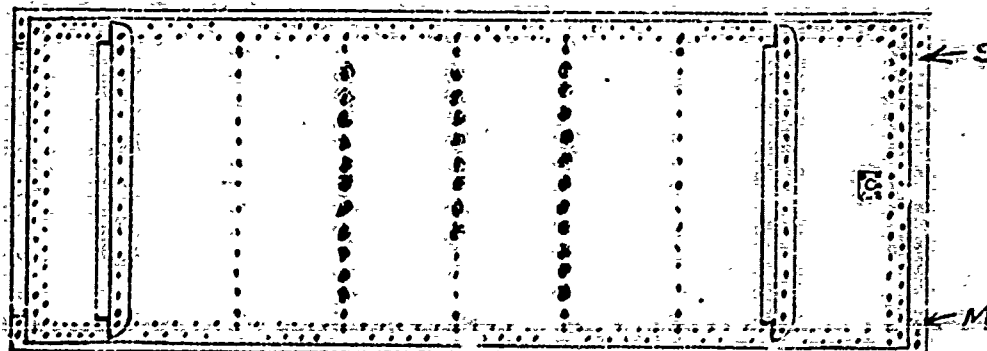
CALC			REVISED	DATE	TANK NO. 3 LEAKAGE TEST NO. 1 AFTER REPAIRS OF SIX LEAKING CORNER'S (SEE PAGE B-14)	03-8297
CHECK						
APR						
APR						
CONTRACT NO.					PAGE 15 104.10

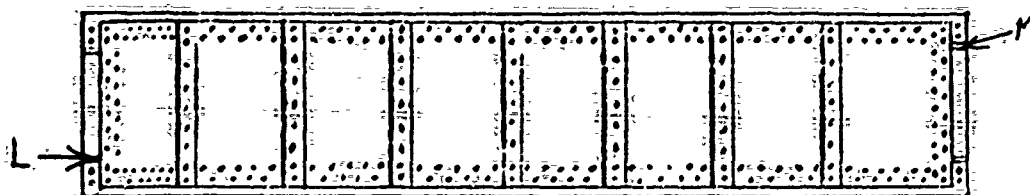
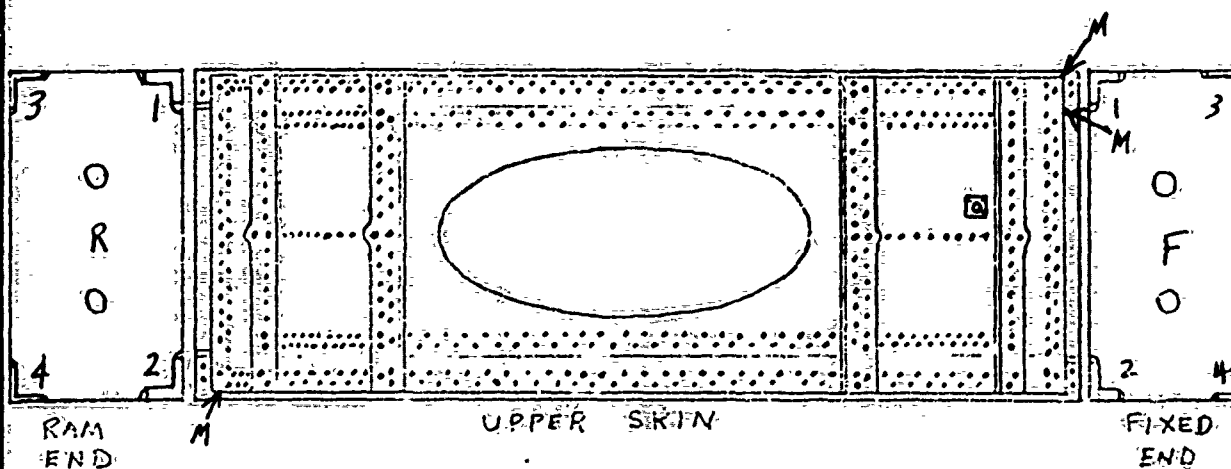
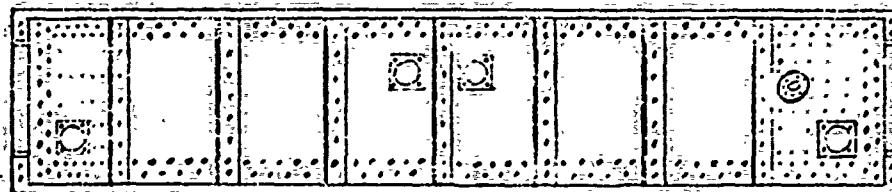
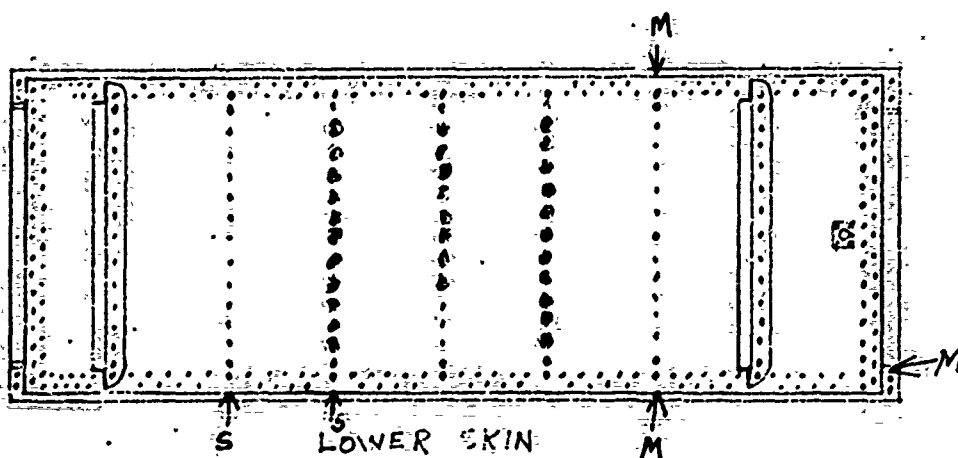
CALC			REVISED	DATE	TANK NO. 3 LEAKAGE TEST NO. 10 AFTER 34 CYCLES OF ENVIRONMENTAL CONDITIONING (SEE TABLE 7)	
CHECK						
APR						
APR						
					THE EIDERING COMPANY AIRPLANE DIVISION - WICHITA, KANSAS	D3-8297
CONTRACT NO.						PAGE B-16
E-10. 10 REV. D						104.11

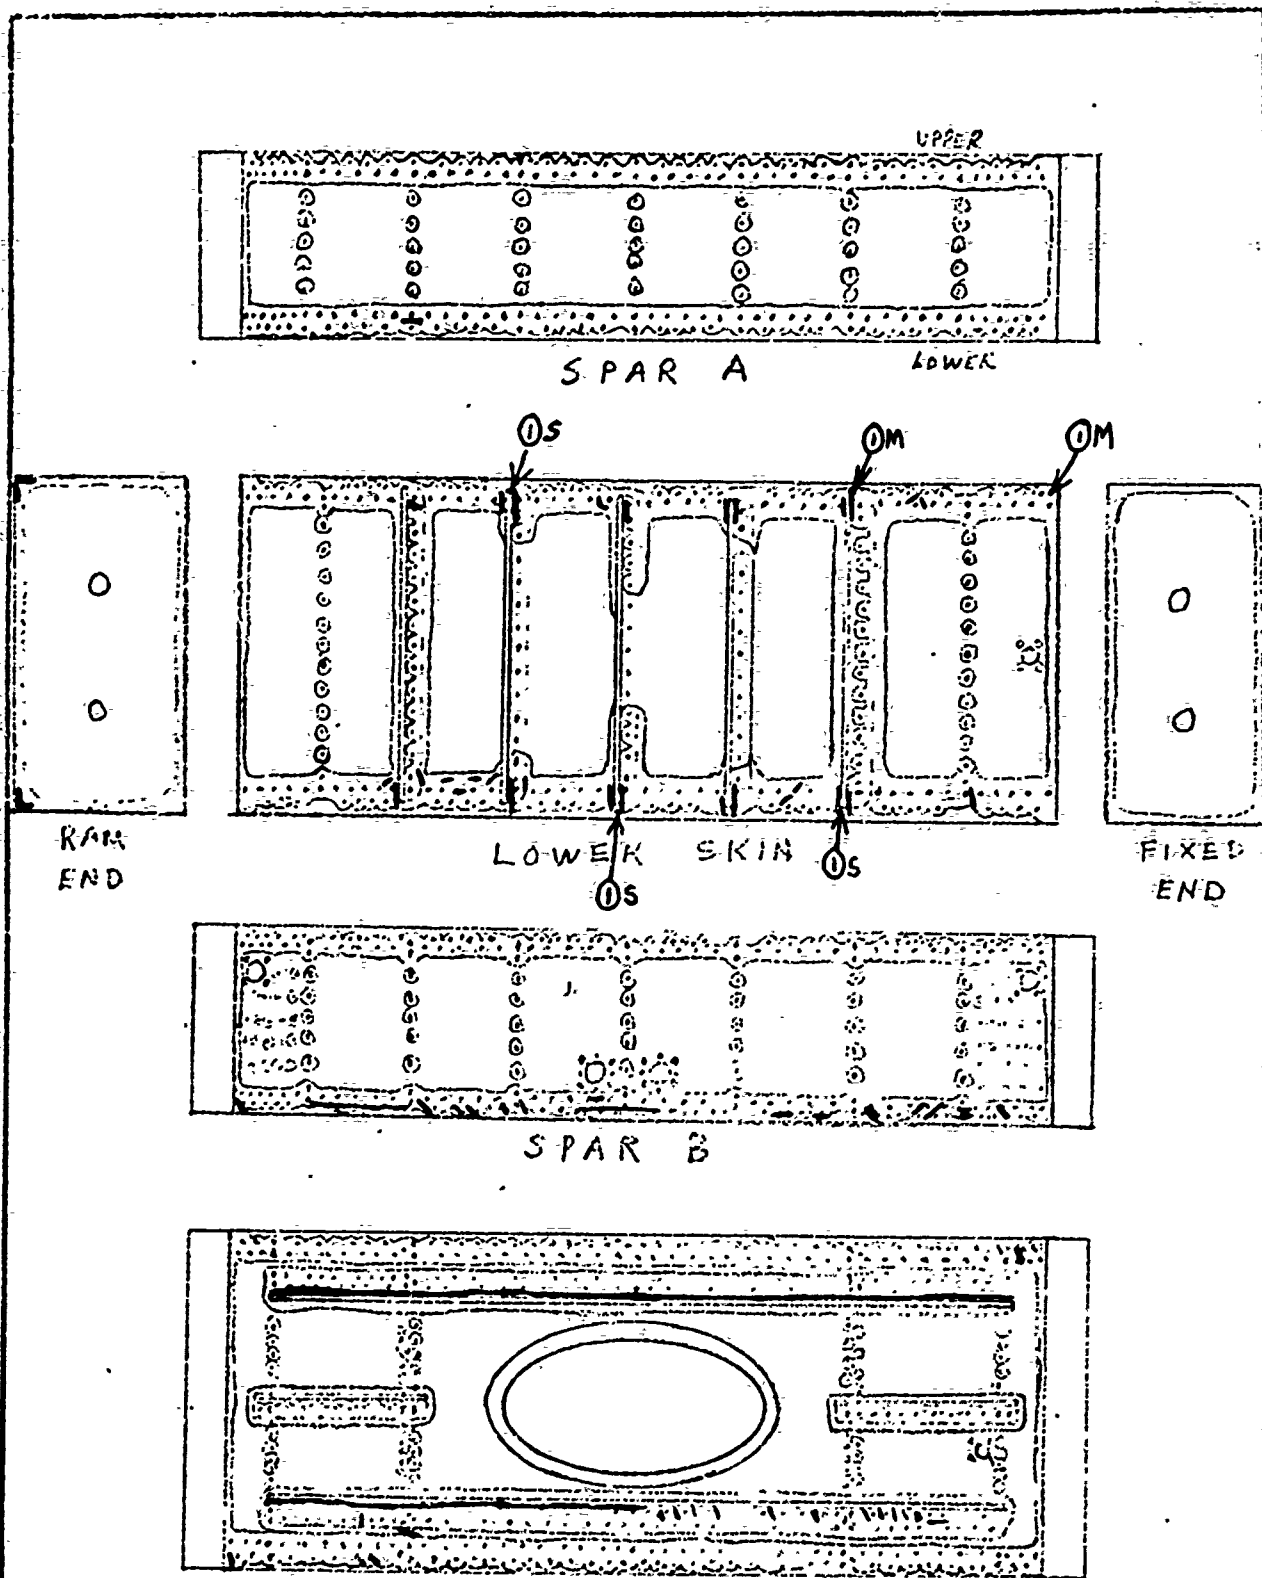
① → INTERIOR LEAK - WATER BUBBLING
THRU 3 PSI VACUUM

CALC			REVISED	DATE	TANK NO. 2 INTERIOR SKIN AFTER 39 CYCLES OF ENVIRONMENTAL CONDITIONING, PLUS 16 HOURS DRY OUT AT 400°F.	D3-8297
CHECK						
APX						
APR						
CONTRACT NO.					FACE B-17 104.12

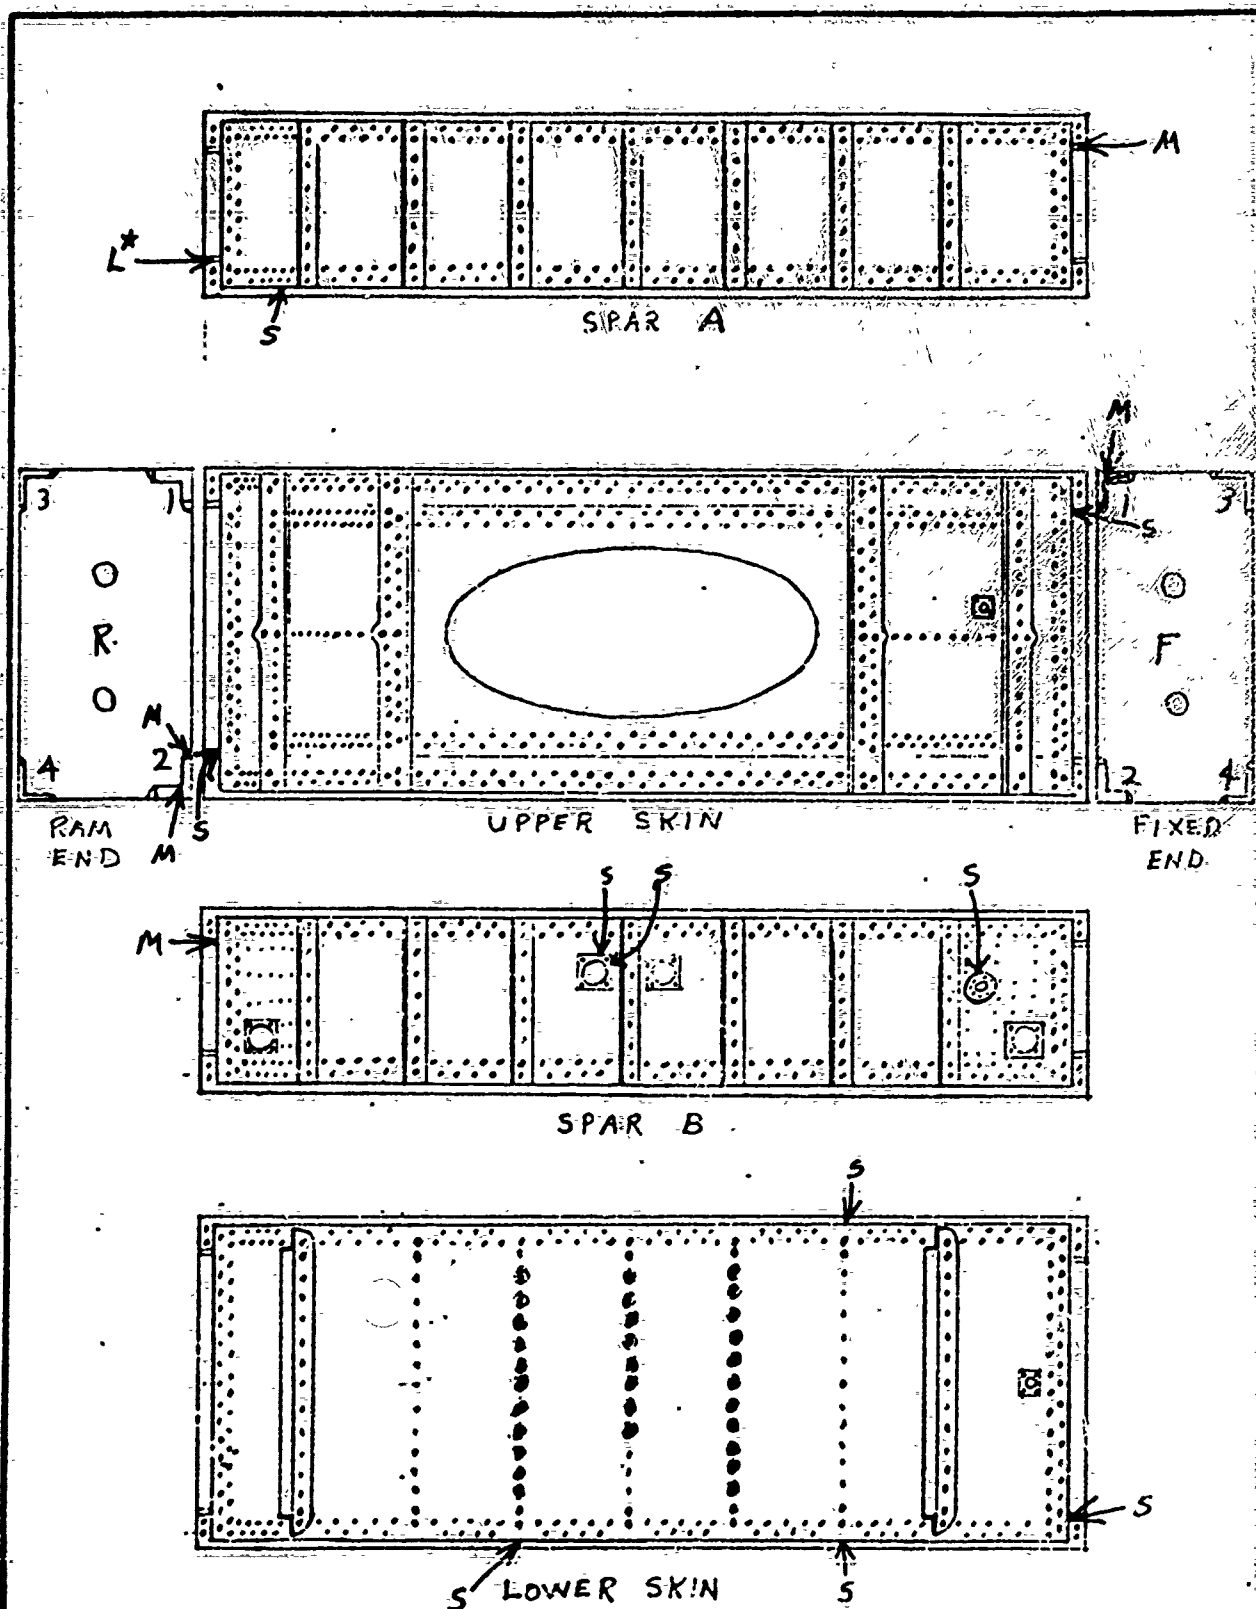
* LEAKED STEADY STREAM WHEN FILLED WITH JP-4 ON TEST JIG | TESTED 8-16-72

CALC		REVISED	DATE	TANK NO. 3 LEAKAGE TEST NO. 11	
CHECK				AFTER 39 ENVIRONMENTAL CONDITIONING CYCLES,	
APR				PLUS LEAK CYCLING AT ALL 3 TEMPERATURES	
APR					03-8297
CONTRACT NO.				THE BOEING COMPANY AIRPLANE DIVISION - WILMINGTON BRANCH	PAGE B-18
					104.13

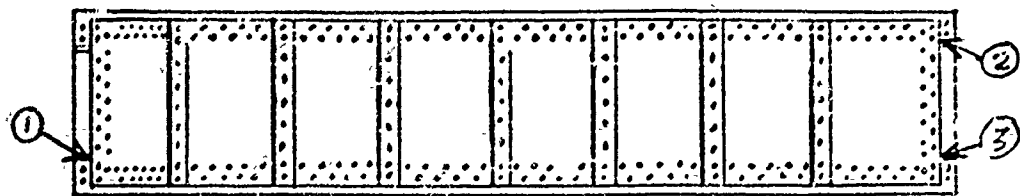
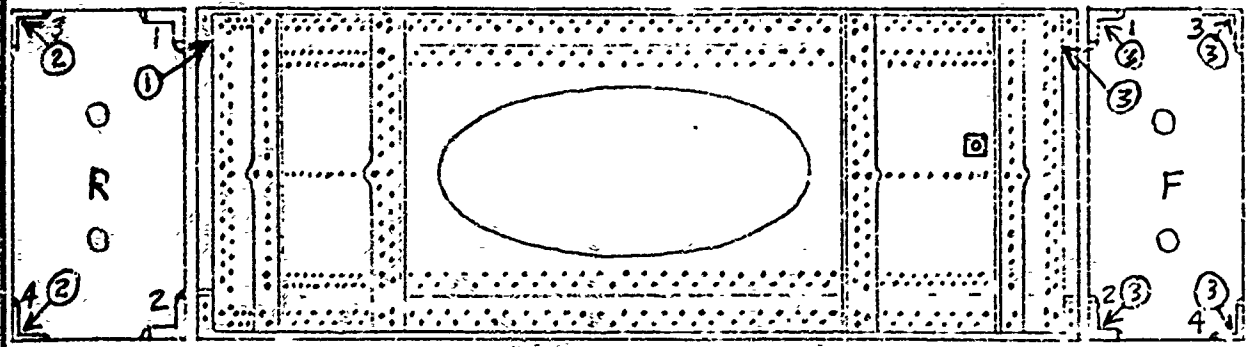
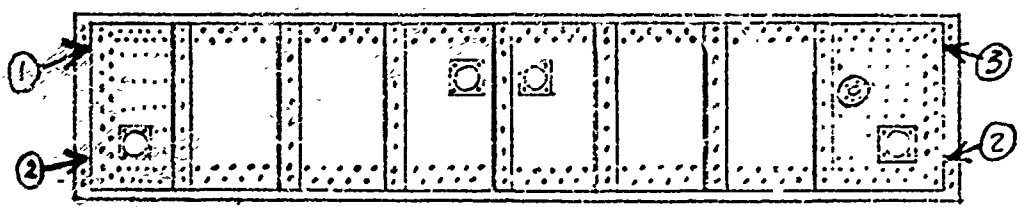
- ① LARGE LEAK
- ② SMALL LEAK
- ③ VERY SMALL LEAK

CALC			REVISED	DATE	TANK NO. 3 LEAKAGE TEST NO. 12 AFTER 46 ENVIRONMENTAL CONDITIONING CYCLES	D3-8297
CHECK						
APR						
APR						
CONTRACT NO.					PAGE 104.14
